NASA TN D-8006

FRICITION AND WEAR OF
CARBON-GRAPHITE MATERIALS
FOR HIGH-ENERGY BRAKES

Robert C. Bill

Lewis Research Center

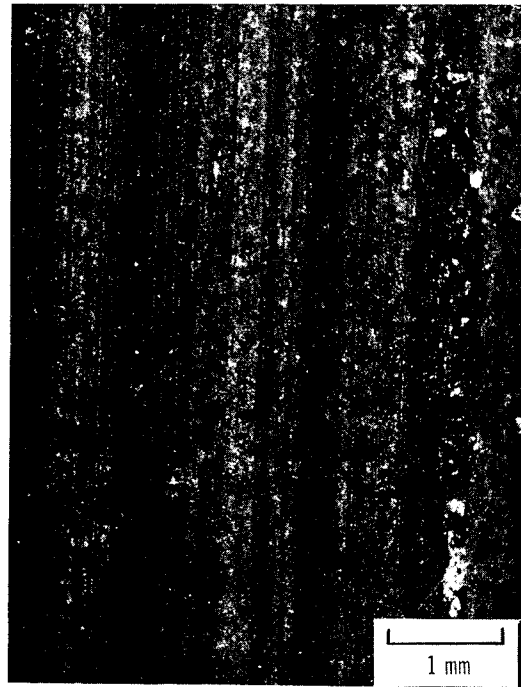
(a) Optical photograph.

(b) Scanning electron micrograph.

Figure 4. - Surface of carbon graphite – high binder (CG-HB) after a combination of simulated-stop and constant-speed exposures under a contact load of 382 N (86 lbf).

Studies of the surface characteristics of the carbon-graphite pads indicate that during sliding the shear takes place in a thin reoriented layer that forms on the pad surface. This concept is discussed in references 6 and 9. Figure 4 shows the surface condition of a CG-HB specimen after a combination of simulated-stop and speed-variation exposures against a 17-22 AS steel disk. This surface is typical of all the carbon-graphite sliding surfaces after such sliding exposures. In these cases, transfer films were also seen on the disk surface. Very few features were apparent in the reoriented layer that developed on the carbon-graphite pad sliding surface. When viewed in room light the layer exhibited a mirrorlike polish.

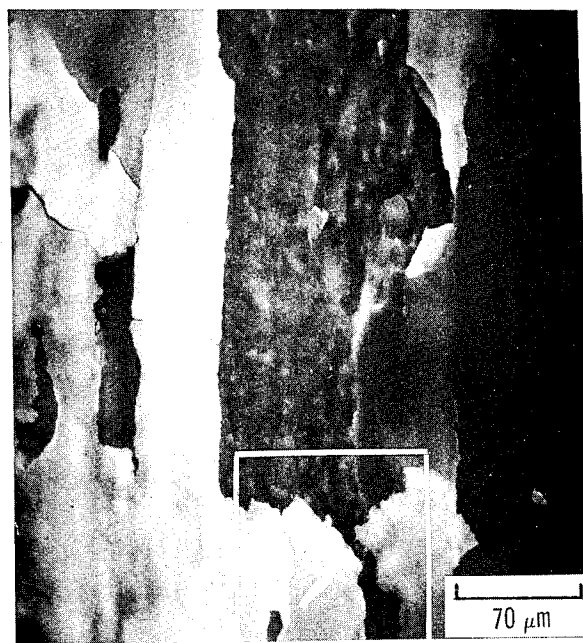
(a) Overview of blistered area.

(b) Enclosed region in (a).

(c) Enclosed region in (b).

Figure 5. - Surface of carbon graphite — low binder (CG-LB) after 1 minute of sliding against a 17-22 AS steel disk at 26 m/sec (83 ft/sec) under a normal load of 422 N (95 lbf).

After exposure to conditions that produced the type of transition described in figure 3, the sliding surface of the carbon-graphite pads showed a distinctly different appearance. On a microscopic scale the sliding surface of the pads showed elongated "blisterlike" features that had a metallic appearance in room light. These features covered about 10 to 20 percent of the surface, the remainder having an appearance like that in figure 4. Examples of these "blistered" areas are shown in figure 5. Here the "blistered" areas are seen to be regions where the shear layer is disrupted; some structural detail is revealed by the way in which the layer breaks up. The shear layer is seen to consist of distinct sheets, probably composed of preferentially oriented graphite. Regions of graphite sheet that have buckled and fractured, with resulting separation from the substrate, are revealed by the "glowing" white areas. The transition to higher friction may then be related to the disruption of a dense, continuous surface shear layer composed of oriented sheets of graphite. According to the literature, disruption can be induced (1) by the desorption of water and other vapors from the shear layer (refs. 6 and 10) and/or (2) by the disruption of the surface oxide present on the metal disk (ref. 9). Once the shear layer is broken up, the pad sliding surface is composed of randomly oriented carbon and graphite particles. Unless the shear layer is restored, sliding will continue to be in a high friction and wear mode.

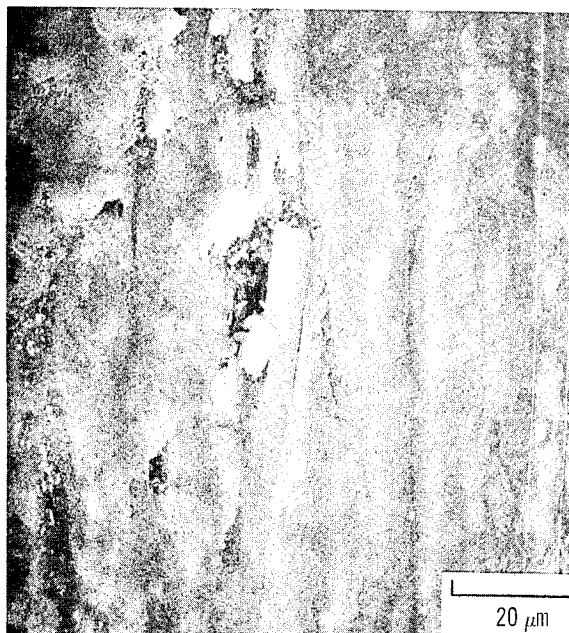
(a) Appearance of general surface.

(b) Enclosed region in (a) showing fiber segment.

(c) Expanded view of fiber shown in (b).

Figure 8. - Surface of carbon graphite – fine fibers (CG-FF) after two 30-second sliding exposures against a 17-22 AS steel disk at 26 m/sec (83 ft/sec) under a normal load of 422 N (95 lbf).

An SEM study was made of the features present on the surface of a CG-FF pad which had been subjected to sliding against a 17-22 AS steel disk. Fiber segments were visible on the wear surface shown in figure 8, and there were signs of interaction of the fibers with the film formed on the pad surface. In particular, surface striations can be seen in figures 8(a) and (b), which suggests an abrasive interaction between the fiber segments and the sliding surfaces. The interaction would have to be caused by loose, broken pieces of fibers as they moved out of the contact area. The fibers constitute comparatively hard, discrete bodies on the sliding surface and have sharp corners and edges generated by fracture. Loose, broken fiber segments certainly have the potential to mechanically disrupt the softer low-shear-strength film - much as an abrasive would. It is a question of fiber concentration as to whether this effect will result in a higher macroscopic wear rate.

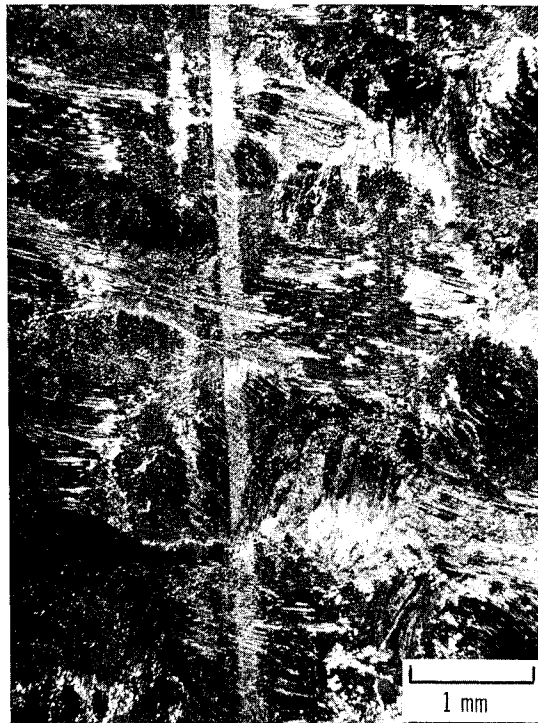
(a) Optical photograph.

(b) Scanning electron micrograph.

Figure 9. - Surface of graphite-cloth-reinforced composite (GCRC) after sliding against a 17-22 AS steel disk in a simulated-stop – speed-variation test.

Friction and wear of graphite-cloth-reinforced composite. - The graphite-cloth-reinforced composite (GCRC) pads were the most wear resistant of the experimental carbon materials when sliding against the 17-22 AS steel disk material. After a sliding exposure, the pad sliding surfaces had a polished appearance with the structure of the graphite cloth apparent, as shown in figure 9. The continuous fiber structure of the composite had remained essentially intact with a continuous film smeared over the sliding surface. Figure 9(b), an SEM photograph, shows the fiber structure barely visible through the surface film.

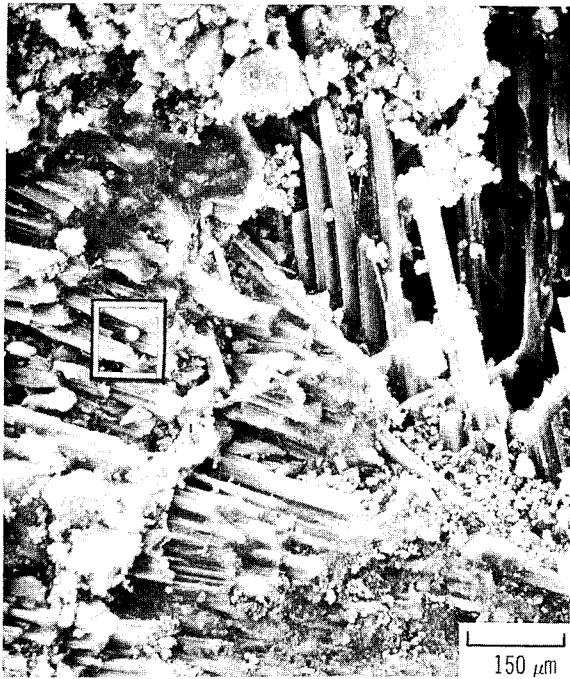
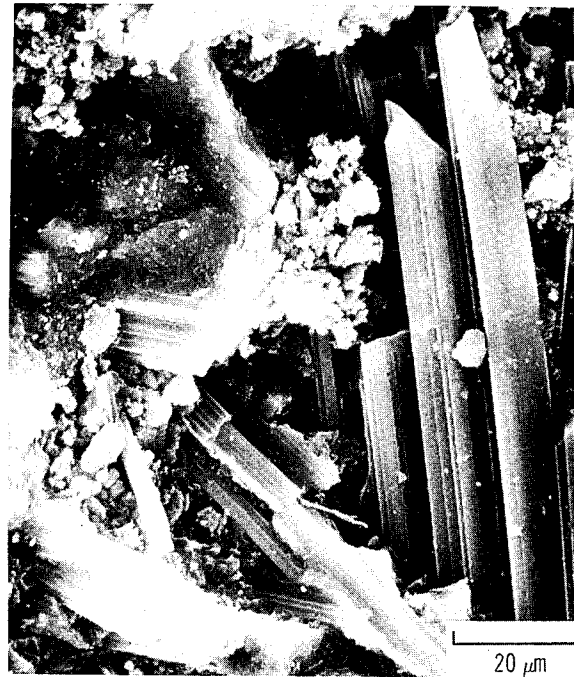
(a) Area of exposed fiber structure.

(b) Region in (a) showing fiber structure of reinforcing cloth.

(c) Enclosed region in (a).

Figure 11. - Surface of graphite-cloth-reinforced composite (GCRC) after sliding against a graphite-cloth-reinforced disk in simulated-stop – speed-variation test shown in figure 10.

shown in figure 10. The severe wear was accompanied by the generation of clouds of loose carbon debris being spewed from the contact area. The condition of the GCRC pad surface after such a sliding exposure was significantly different from that shown in figure 9. Exposed fibers are obvious in the SEM photographs of figure 11. A remarkable feature of the GCRC material shown in these photographs is the very irregular, sharp-edged fiber cross section. The lack of any coherent shear layer on the pad sliding surface is good evidence that fiber exposure ultimately leads to the disruption of this layer. The shape of the fibers and the high mechanical strength associated with them would enable them to act as potentially abrasive constituents on the pad surface.
